Eurasian water-milfoil (*Myriophyllum spicatum*) SCUBA Dive Monitoring Survey Tomahawk Lake – WBIC: 2501700 Bayfield County, Wisconsin

Project Initiated by: The Wisconsin Department of Natural Resources
and the Town of Barnes – Aquatic Invasive Species Committee

Survey Conducted by and Report Prepared by:
Endangered Resource Services, LLC
Matthew S. Berg, Research Biologist
St. Croix Falls, Wisconsin
September 3, 2016

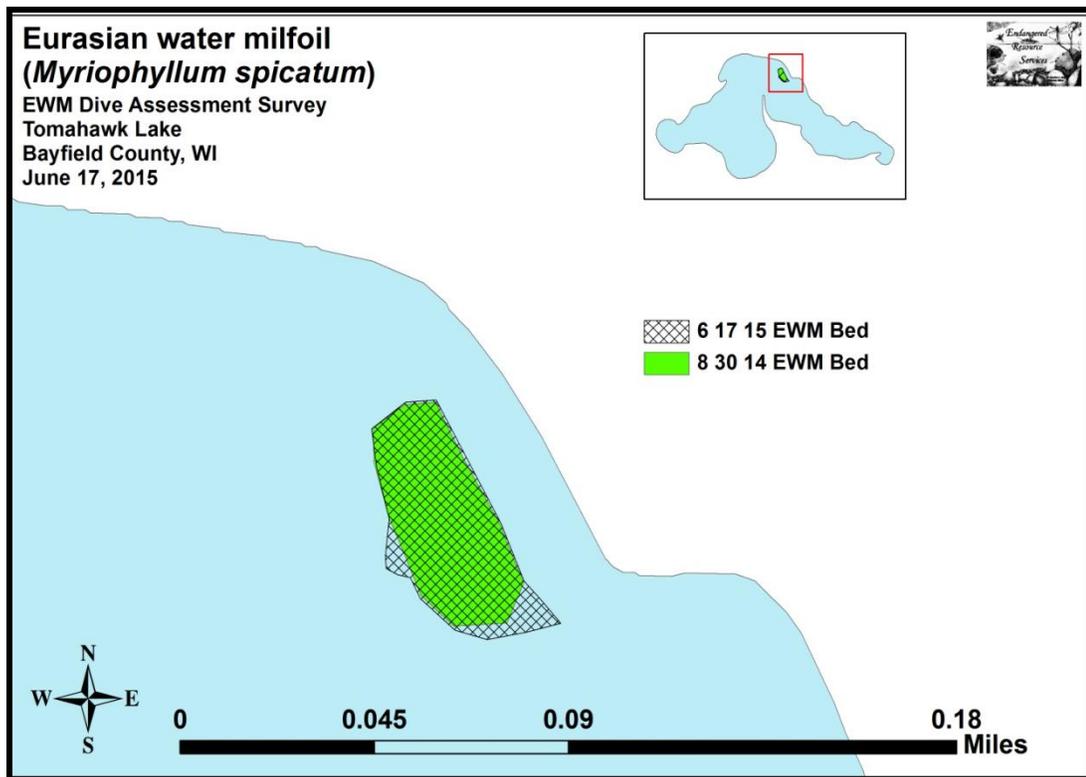
During the August 30, 2014 survey, we found EWM was actively growing and expanding within a 0.69 acre bed centered around the location of the original infestation west of the park. By the June 17, 2015 survey, this had expanded to cover 0.81 acre (Figure 2). The core bed continued to thicken and expand throughout the summer of 2015 with many patches nearing canopy. The August 11, 2015 survey found EWM now covered 1.53 acres or approximately 44% of the 3.48 acres treated in 2013 (Figure 3).

Figure 2: EWM Locations on Tomahawk Lake – 6/17/15

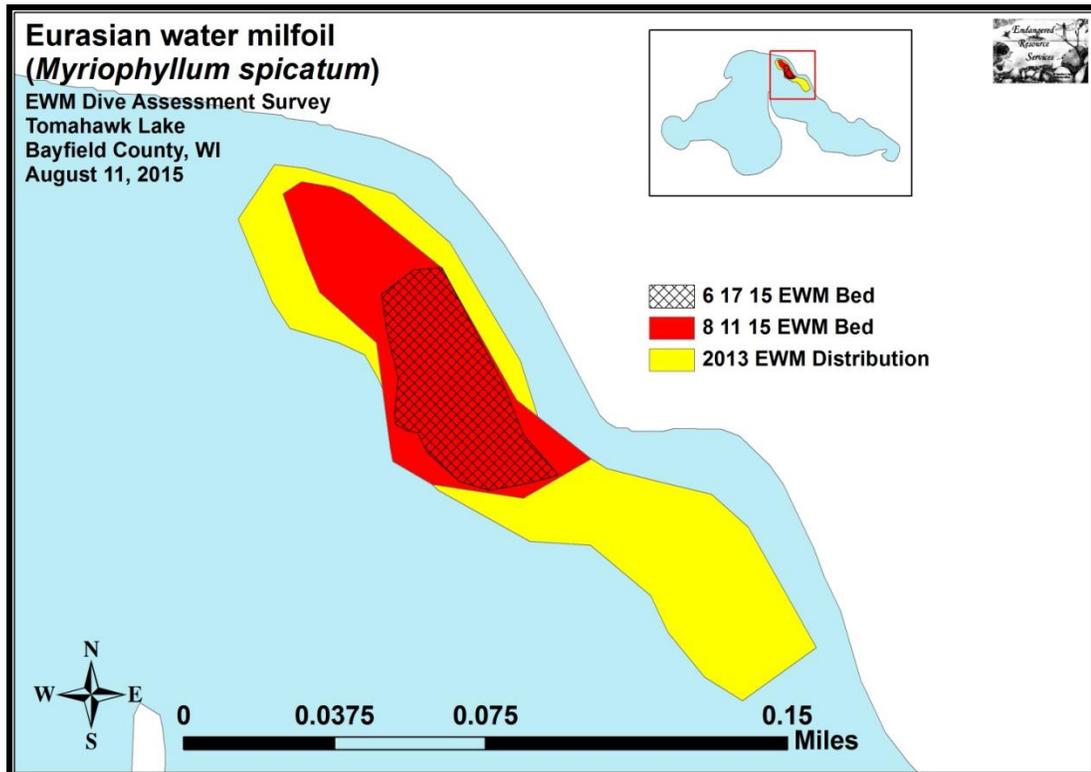
Figure 3: EWM Locations on Tomahawk Lake – 8/11/15

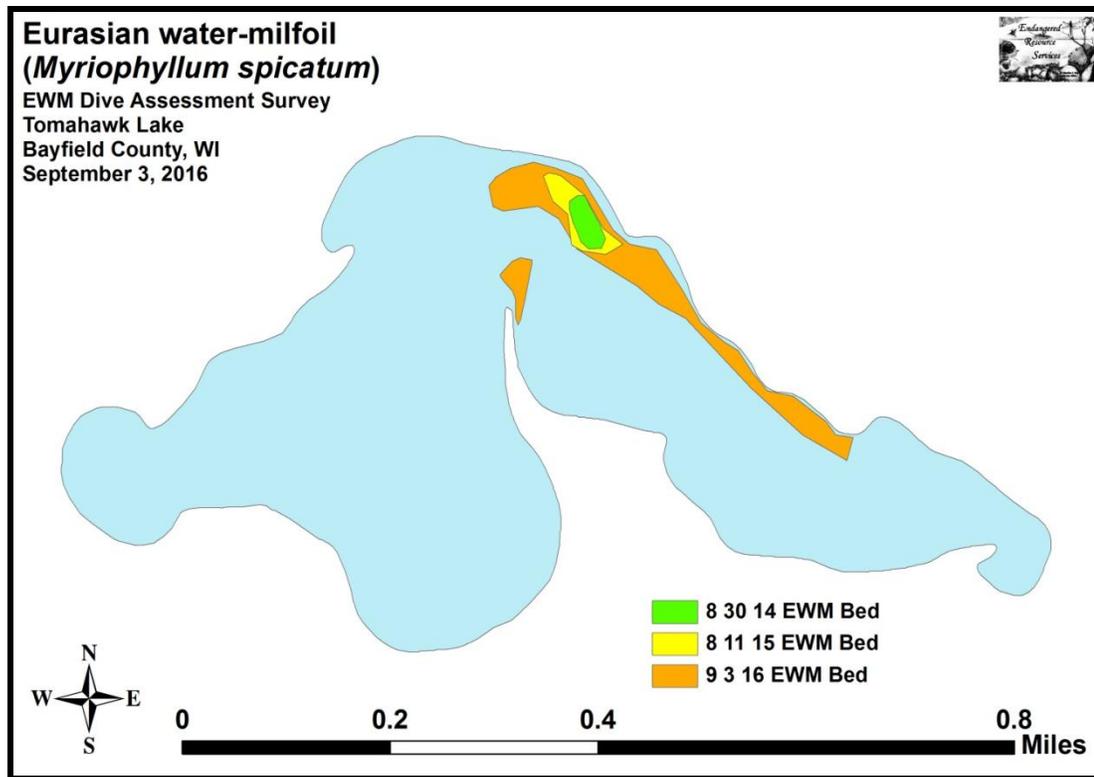
The summer of 2016 was a time of significant EWM expansion on the lake. By September 3rd, we found EWM had spread down the majority of the northeast shoreline and now covered 7.40 acres – more than twice the size of the 2013 treatment area (213% of the 2013 total) and was almost five times the size of the bed mapped in August 2015 (484%). Additionally, we found a second bed had established on the point southwest of the original infestation, and it covered 0.59 acre bringing the total area with significant EWM to 7.99 acres (Figure 4). Equally troubling was the rate at which EWM was excluding native vegetation. Where there had been at least patches of native pondweeds within the boundaries of the August 2015 bed, we found a dense canopied monoculture of EWM in 5-8ft of water in 2016 (Figure 5). As would be expected, we noted the density and percent cover decreased radiating outward into the newly mapped areas. However, the rate of fragmentation and expansion in these areas was spectacular with plants barely 2ft tall already dropping side branchlets. Based on this and the 10’s/perhaps 100’s of floating fragments we saw throughout the eastern bay, we full expected another significant expansion next year and wouldn’t be surprised to see EWM established throughout the entire littoral zone by the end of 2017.

Figure 4: EWM Locations on Tomahawk Lake – 9/3/16

The TOB now has a functional Diver Assisted Suction Harvest (DASH) system that will be available for use in the summer of 2017. But, due to the significant expansion of EWM in 2016 and the potential for further expansion in 2017, a bed or potentially lake-wide herbicide treatment may be necessary to “reset the clock” to the point a DASH system could keep up with expected EWM growth. Ideally, if an active management strategy is decided upon, it will begin/occur as early in the 2017 growing season as possible before the infestation can spread further.

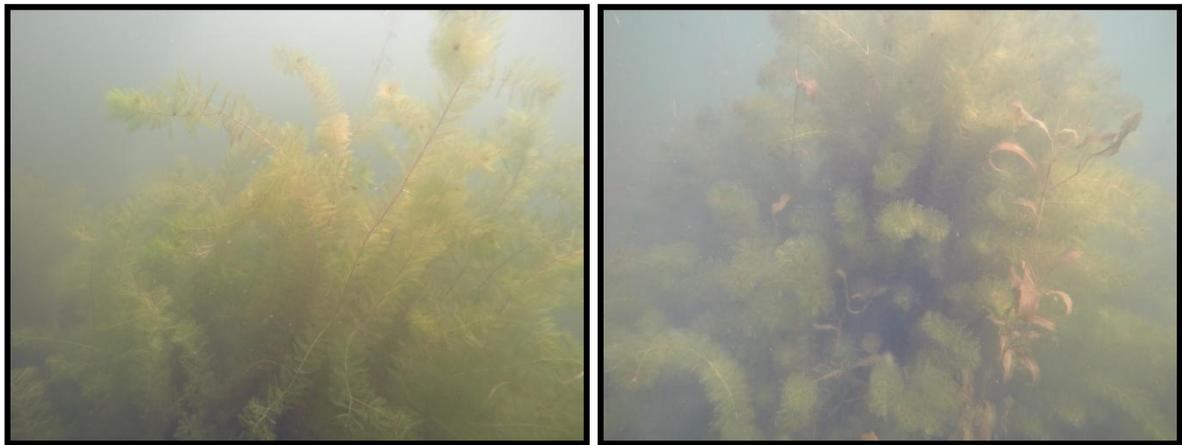
**Figure 5: Dense EWM Towers Excluding Almost All Native Vegetation
 Tomahawk Lake – 9/3/16**
